SUBJ: RCRA Compliance Evaluation Inspection  
Aerospace Coatings International, LLC  
EPA ID Number: ALR000026872

## **RCRA Inspection Report**

Aerospace Coatings International, LLC (ACI) in Oxford, Alabama, is an aircraft maintenance, repair and overhaul repair facility that specializes in hydraulic, pneumatic and landing gear piece part repair.

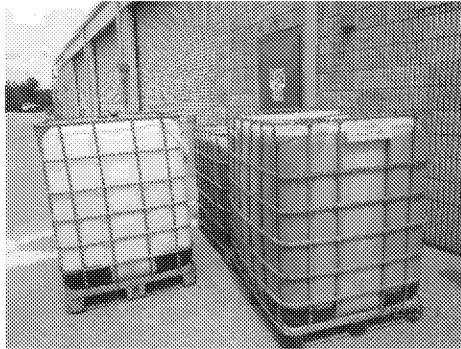
Picture [ SEQ Picture \\* ARABIC ] – Chromic Acid tote

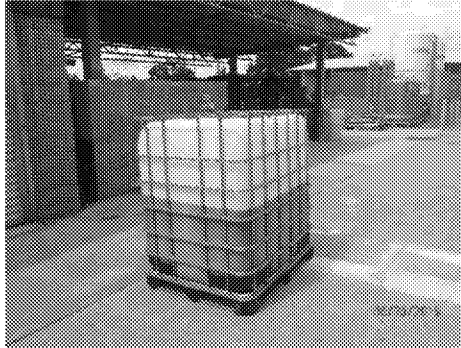
Picture [ SEQ Picture \\* ARABIC ] – Staging Area process materials for reuse

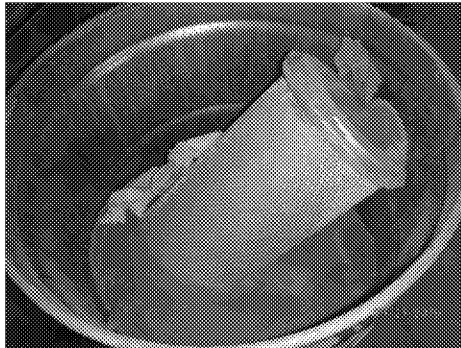
Picture [ SEQ Picture \\* ARABIC ] – Staging Area process materials for reuse

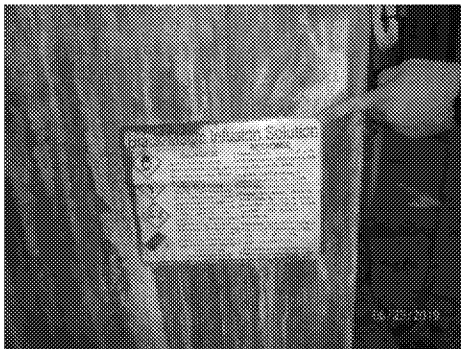
Picture [ SEQ Picture \\* ARABIC ] – Plating Room chromic acid secondary containment

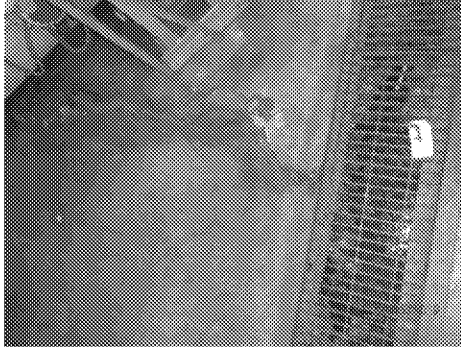
Picture [ SEQ Picture \\* ARABIC ] – OD Shop released hydraulic oil in floor grate

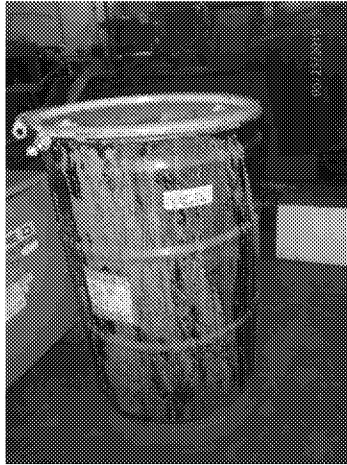
Picture [ SEQ Picture \\* ARABIC ] – OD Shop released hydraulic oil in floor grate

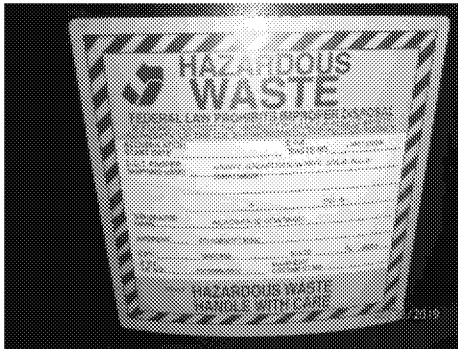
Picture [ SEQ Picture \\* ARABIC ] – OD Shop Shot Peen spent coolant to floor grate

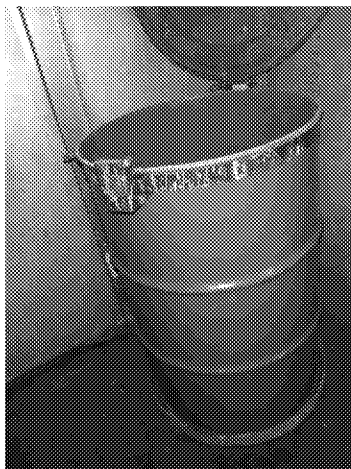
Picture [ SEQ Picture \\* ARABIC ] – ID Shop Paint Booth SAA drum

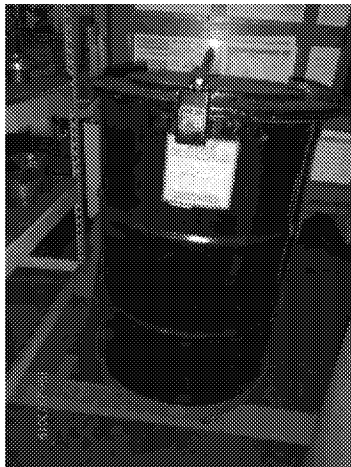
Picture [ SEQ Picture \\* ARABIC ] – ID Shop PPE and debris SAA

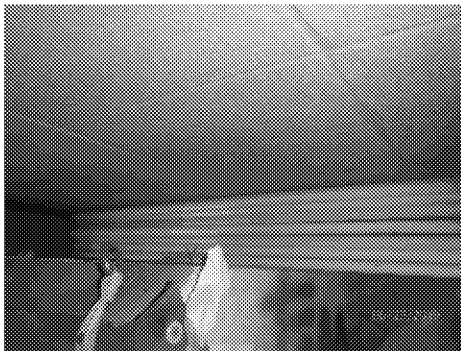
Picture [ SEQ Picture \\* ARABIC ] – ID Shop Paint Booth spent fluorescent lamps

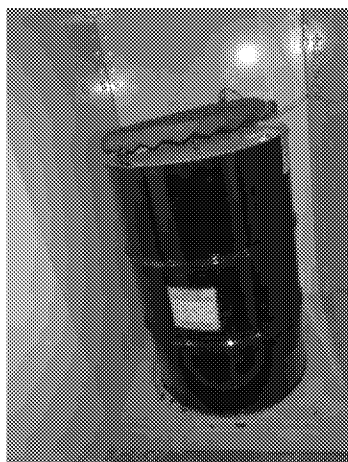
Picture [ SEQ Picture \\* ARABIC ] – Maintenance HW MEK SAA

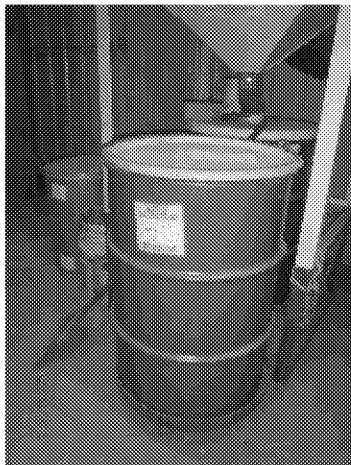
Picture [ SEQ Picture \\* ARABIC ] – Landing Gear Shop  
spent blast media

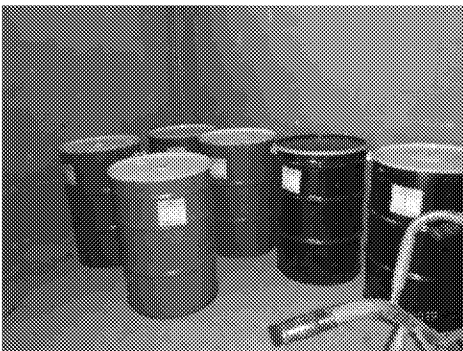
Picture [ SEQ Picture \\* ARABIC ] – CAA HW Chromic Acid waste drums

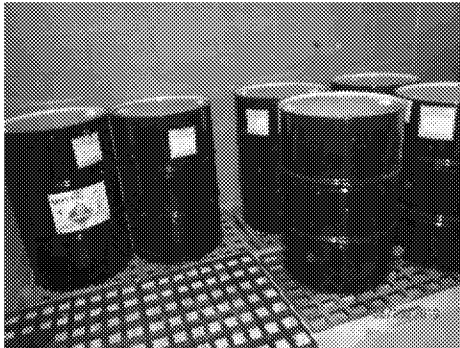
Picture [ SEQ Picture \\* ARABIC ] – CAA HW MEK waste drums

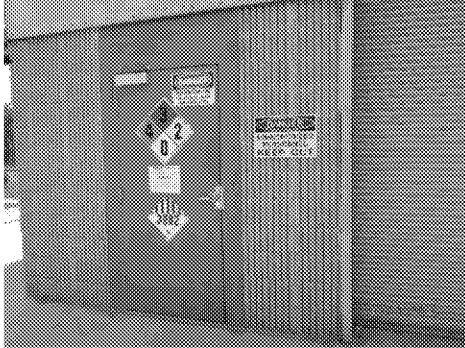
Picture [ SEQ Picture \\* ARABIC ] – CAA entrance and signs
